SMITHSONIAN INSTITUTION
BUREAU OF AMERICAN ETHNOLOGY
BULLETIN 121

ARCHEOLOGICAL REMAINS IN THE WHITEWATER DISTRICT EASTERN ARIZONA

PART I. HOUSE TYPES

By FRANK H. H. ROBERTS, JR.

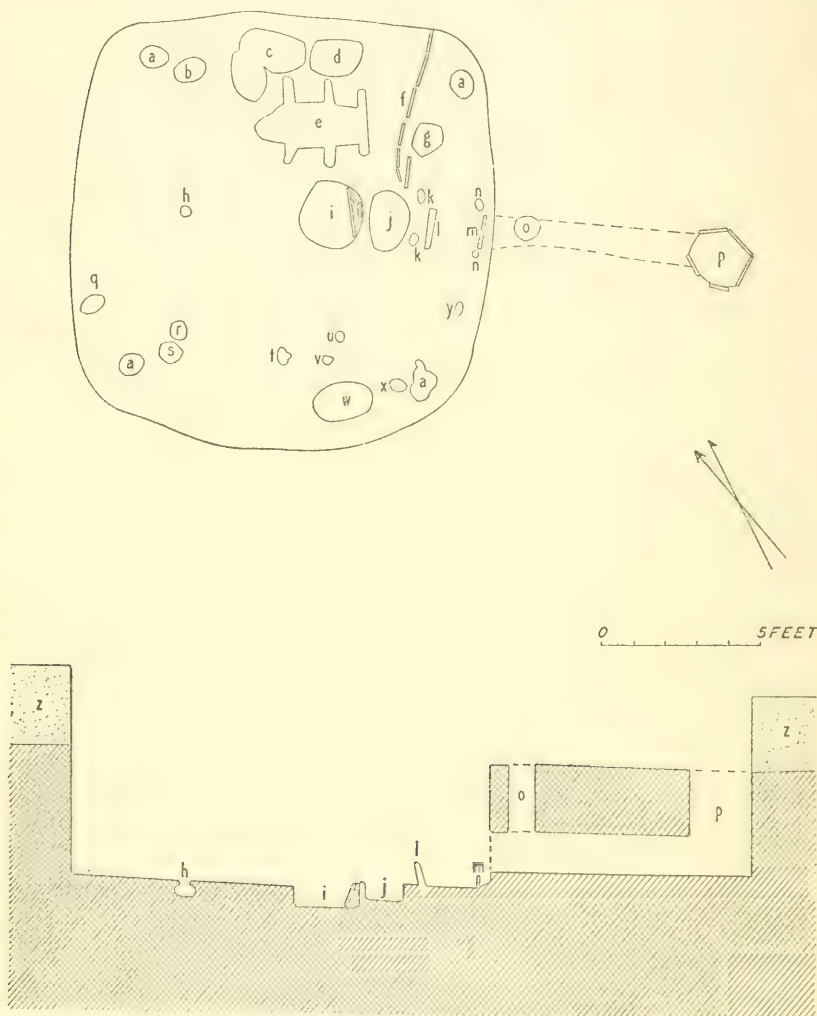
FIGURE 2.—Structure 1. *a*, holes for support posts; *b*, *c*, and *d*, storage basins; *e*, basin in floor; *f*, wall forming compartment; *g*, basin in floor; *h*, sipapu; *i*, fire pit; *j*, ash pit; *k*, ends of ladder poles; *l*, deflector; *m*, stone to protect ventilator opening; *n*, pole placement; *o*, small shaft in ventilator; *p*, main ventilator shaft; *q*, pot rest or storage hole; *r*, *s*, *t*, *u*, *v*, *w*, *x*, and *y*, storage holes and basin; *z*, sand accumulation above old ground level.

The larger basin-like depressions (fig. 2, *c*, *d*, *w*) possibly served as places in which baskets or jars were set, although there was no indication that such had been the case. What function the curiously shaped depression *e* may have been intended to fulfill is a question for which no answer has been found. At the time when the remains were excavated a small pitcher of the culinary variety of pottery was sitting in the end toward the ventilator side of the room. Several who saw the house suggested that loom sticks may have been placed across the depression in the arm-like projections at each side of the central portion. In view of weaving practices in general, as they are known throughout the Southwest, this does not seem to be a good explanation. There was nothing about the depression itself to furnish a clue.

The hole marked *h*, figure 2, corresponds in its general size and position to similar ones found in most pit houses and in many present-day kivas. In the kivas or ceremonial chambers the feature is called the sipapu, because the modern Pueblos use that name or a close variation of it to designate the hole. According to them it symbolizes the mythical place of emergence through which their ancestors are supposed to have passed in their journey from the inner portions of the earth, where they were created, to the surface of the world upon which they now live. Whether a similar interpretation was made in the past or not is a matter of conjecture. The belief is so firmly implanted in Pueblo mythology, however, that it may with considerable justification be assumed that the prehistoric people regarded the feature in the same light. A further support for this theory is derived from

seven stones forming a bin-like enclosure at the southeast corner of the room (fig. 2, *f*; pl. 3, *a*). One of the typical interior elements in Modified Basket Maker houses consists of a low wall of stone slabs separating the ventilator or, as was the case in many of the dwellings of that period, the entrance side of the chamber from the rest of the room. Sometimes the partition wall extended entirely across from support post to support post. Then again it was broken by a doorway in front of the passage opening into the wall. Occasionally a house is found that only has corner bins at that side of the room.²⁰ The enclosure in one corner of No. 1 is very suggestive of the more complete examples found in the Chaco Canyon houses and possibly represents a survival in the houses of a later day of a characteristic common during a previous stage in house development. The purpose of such compartments is not known. Two metates or grinding stones were found in the present example. This would suggest that the enclosure may have served as a mealing bin for the house. On the other hand it is quite possible that the stones were placed there during intervals when they were not in use, since one was leaning against the partition and the other against the wall. The bin may have served solely in the capacity of a storage place. Firewood, jars containing surplus food and other items connected with the daily life of the people could have been placed there where they would not interfere with the general trend of affairs in the main part of the structure. Somewhat comparable enclosures in the earth lodges of some of the Plains Indians, dwellings which in many ways bear a strong resemblance to the pit houses of the Southwest, despite the fact that they were largely surface structures, were employed for storing the supply of firewood in winter.²¹

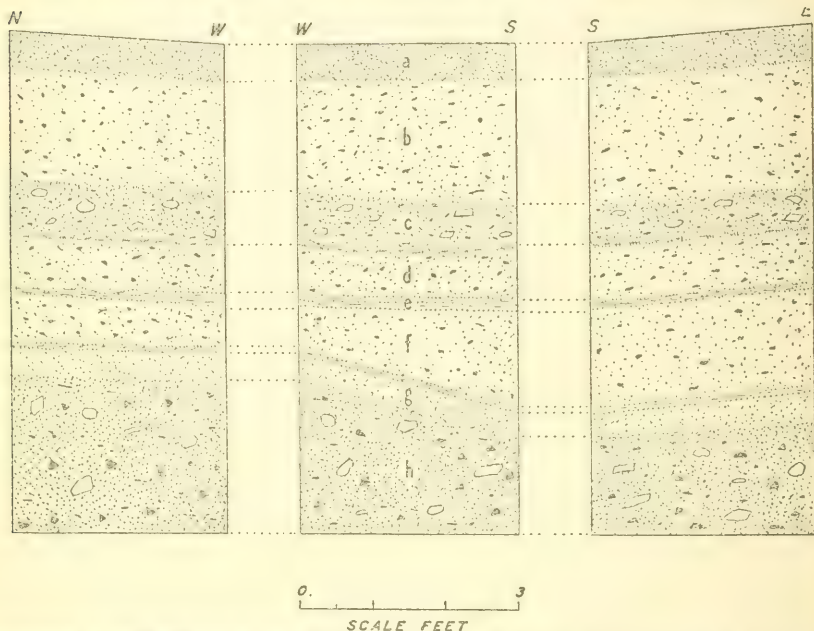
FIGURE 3.—Pillar left from fill in structure 1. N, W, S, and E, indicate north, west, south, and east corners. *a* to *h*, Strata in fill.

The second stratum (fig. 3, *b*) was considerably thicker than the first. It was 1 foot 6 inches (45.72 cm) from top to bottom. The main content was blow sand and ashes with some charcoal. Toward the lower half there was a marked increase in the number of potsherds present. In fact there was only one other layer in the entire pillar which contained more. This would suggest that there was considerable activity around the site at that time and the remains of many broken vessels found their way into the abandoned pit. The stratum did not give distinct evidence at this point of having typical refuse material in it and it does not seem that it can be attributed to house sweepings and other waste matter being dumped there. Rather would the character of the fill at this point suggest a more or less natural gravitation of objects into a depression.

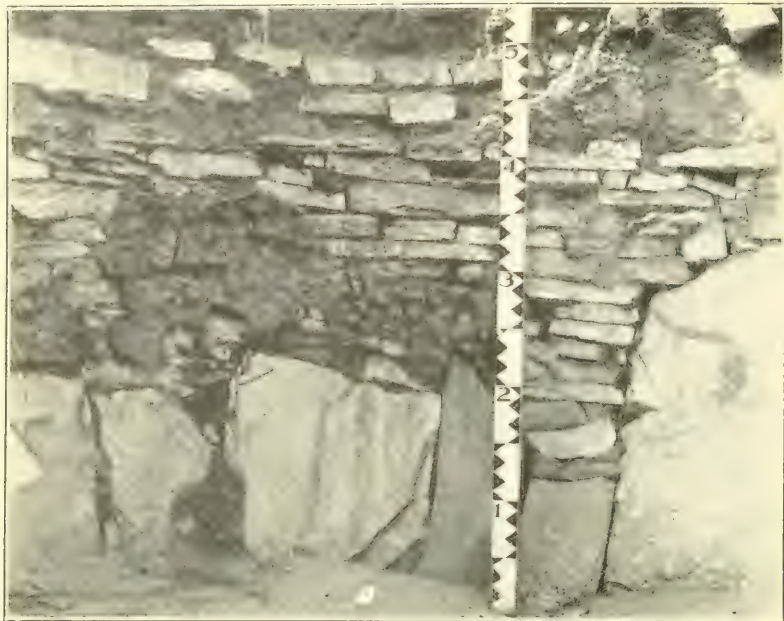
a. Masonry wall resting on slab foundation.

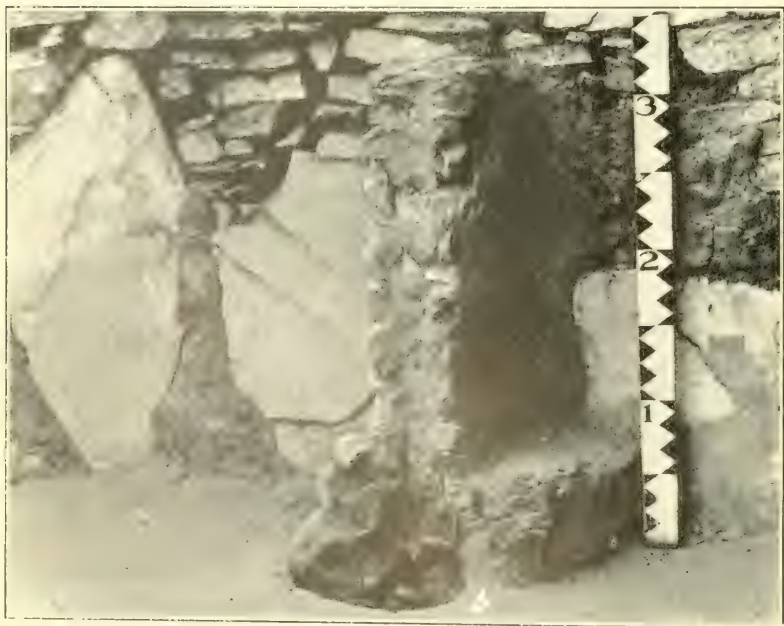
b. Pilaster in structure 2.

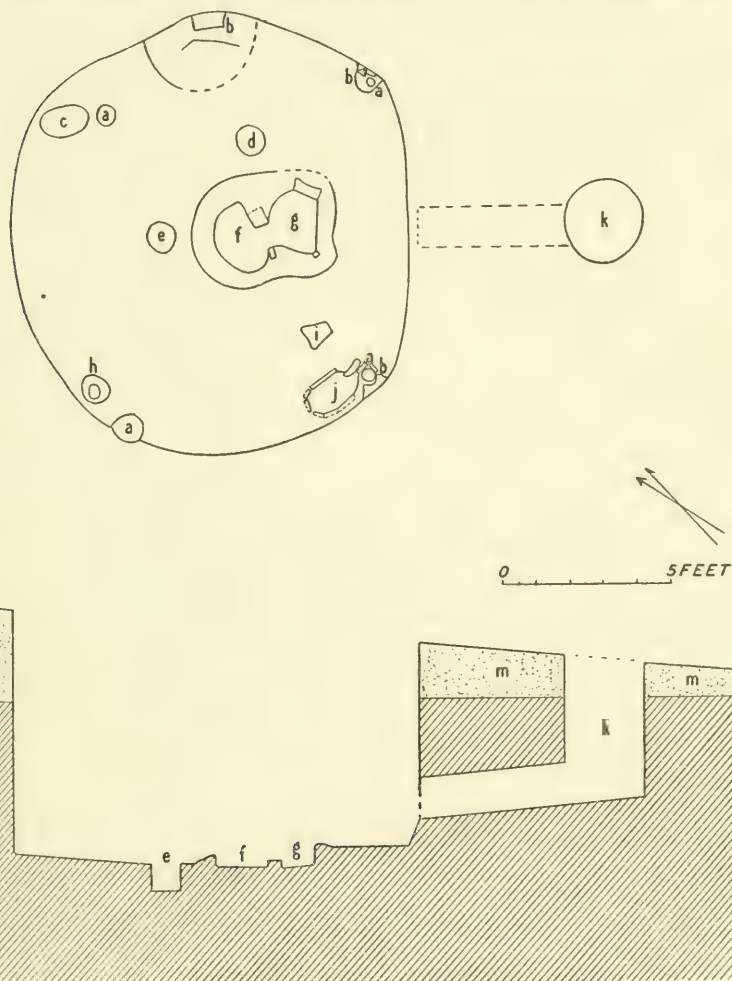
FIGURE 6.—Structure 3. *a*, support posts for superstructure; *b*, pilasters; *c*, storage basin; *d*, storage hole; *e*, sipapu; *f*, fire pit; *g*, ladder box; *h*, storage hole; *i*, stone embedded in floor; *j*, secondary fire pit; *k*, ventilator shaft; *m*, sand accumulation above old surface.

The superstructure was supported by four posts set in the floor and one pilaster or masonry pillar. Two of the support posts had been braced with mud plaster placed between them and the wall in the same fashion that the post in No. 2 had been buttressed (pl. 7, *b*). One curious factor in this connection is that in both Nos. 2

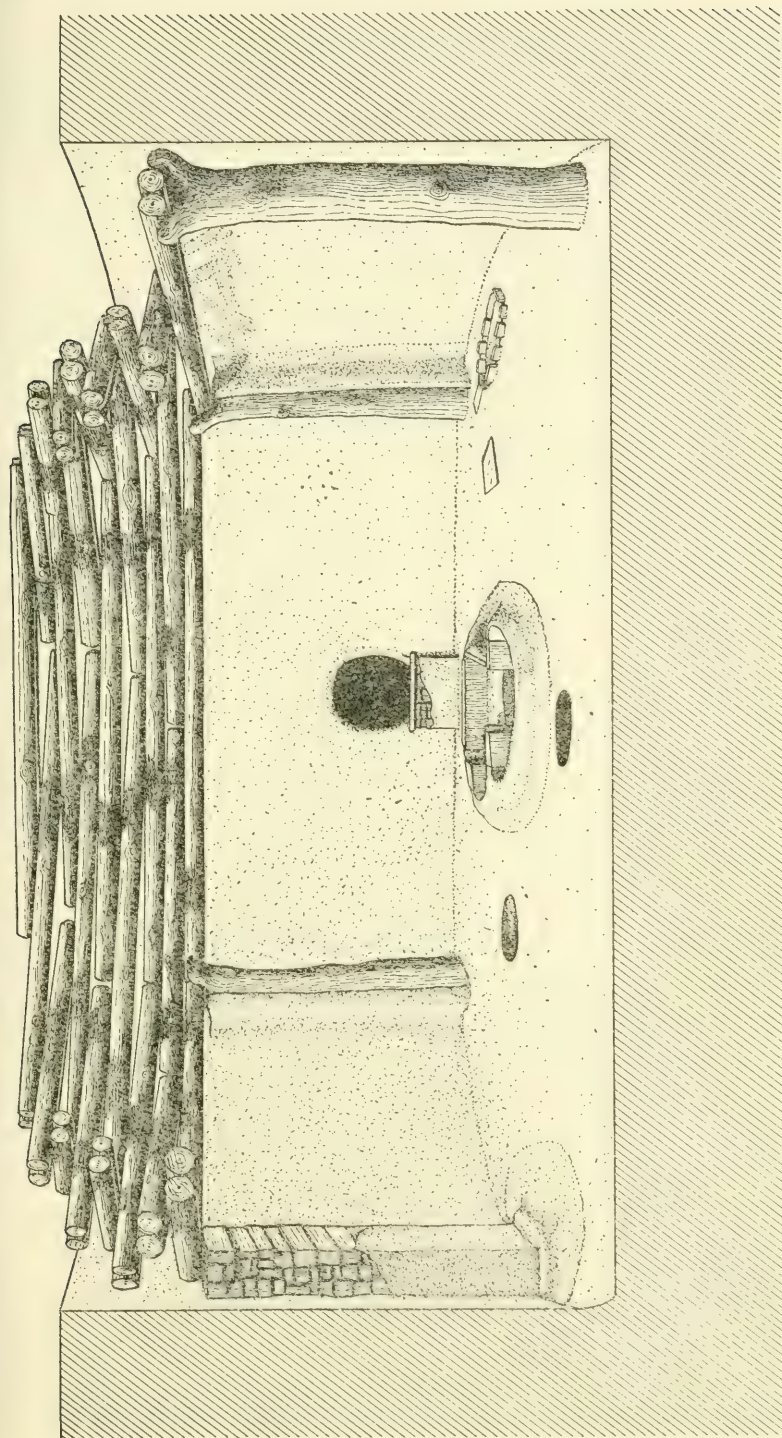
FIGURE 7.—Postulated reconstruction of cribbed roofing erected over pit of structure 3. One side removed to show method of laying timbers.

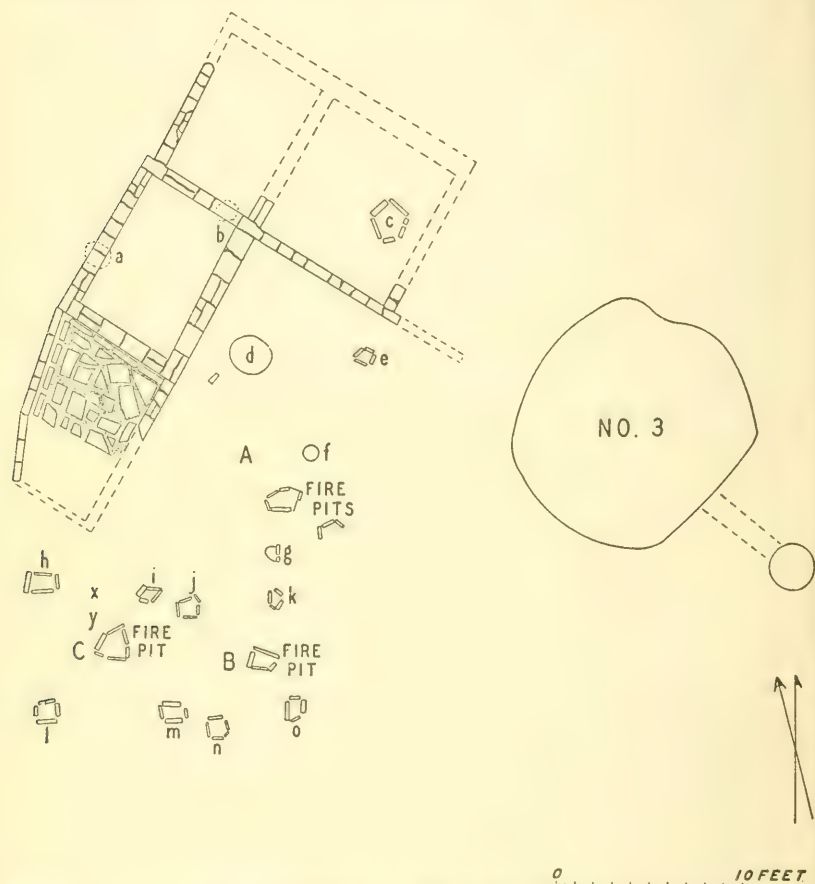
FIGURE 8.—Remains of surface building A. *a* and *b*, fire pits beneath foundations; *c*, fire pit in floor of room; *d*, opening into pit oven; *e*, *f*, and *g*, placements for portico posts; *h*, *i*, *j*, *k*, *l*, *m*, *n*, and *o*, placements for shelter posts; *x*, location of fragment of child's skull; *y*, location of black-on-white bowl.

extended across former fire pits (fig. 8, *a*, *b*). At the time the structure was built these pits were apparently on or just below the existing level of occupation. They were filled with stones and mud before the wall was carried across them (pl. 8, *a*). Another feature, that of a porch or portico, was indicated by the row of post molds or holes along the front of the structure. A similar feature was found near house 15 and inasmuch as the latter exhibited better the

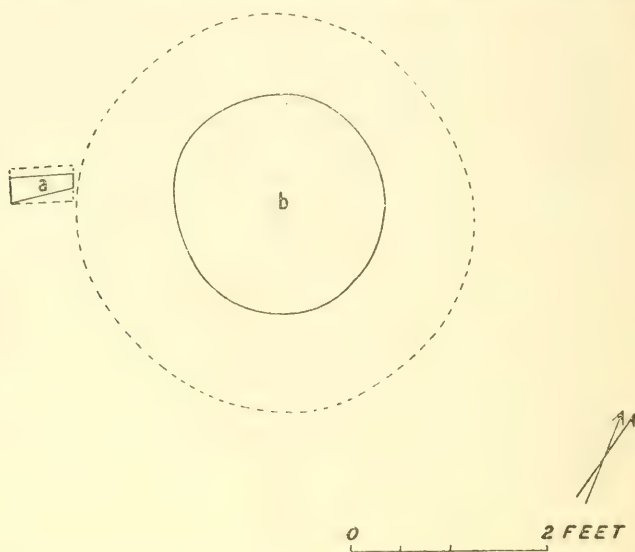
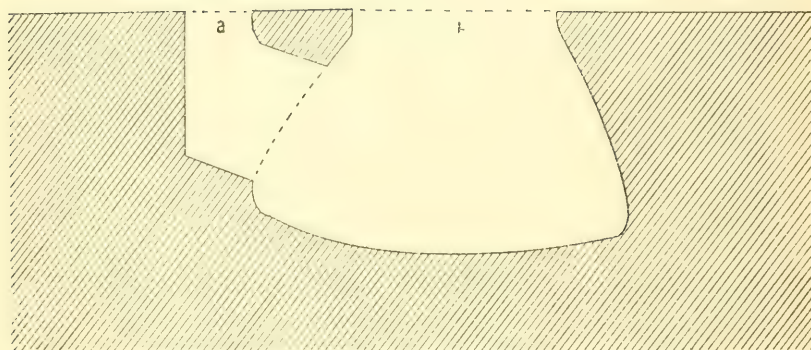
FIGURE 9.—Pit oven. *a*, flue; *b*, opening on ground level.

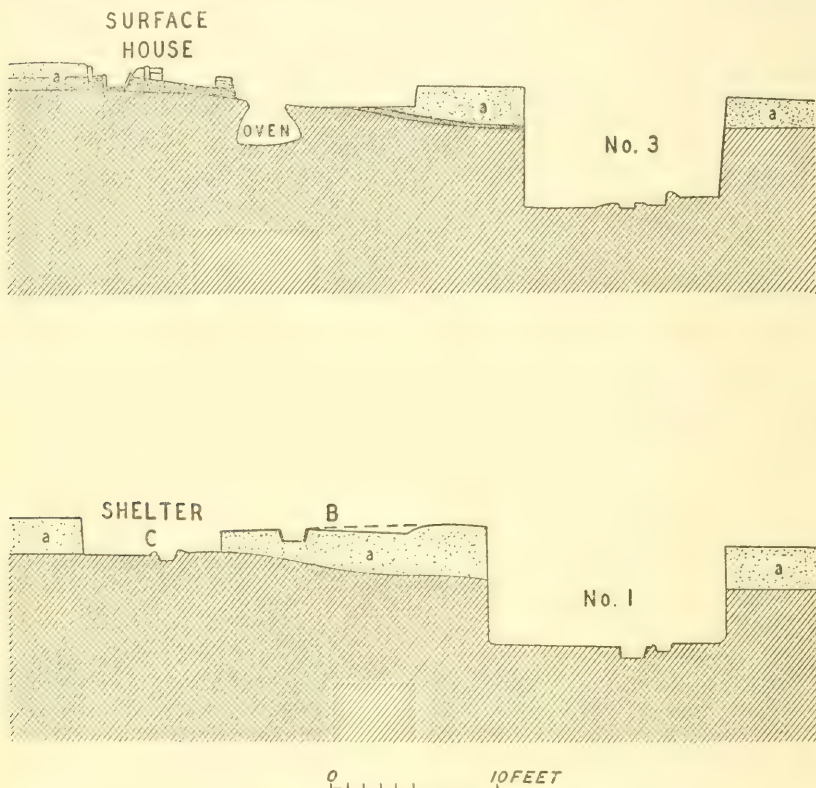
FIGURE 10.—Sections through surface remains A, pit oven and structure 3, shelter and structure 1. *a*, accumulation of sand above original surface of occupation.

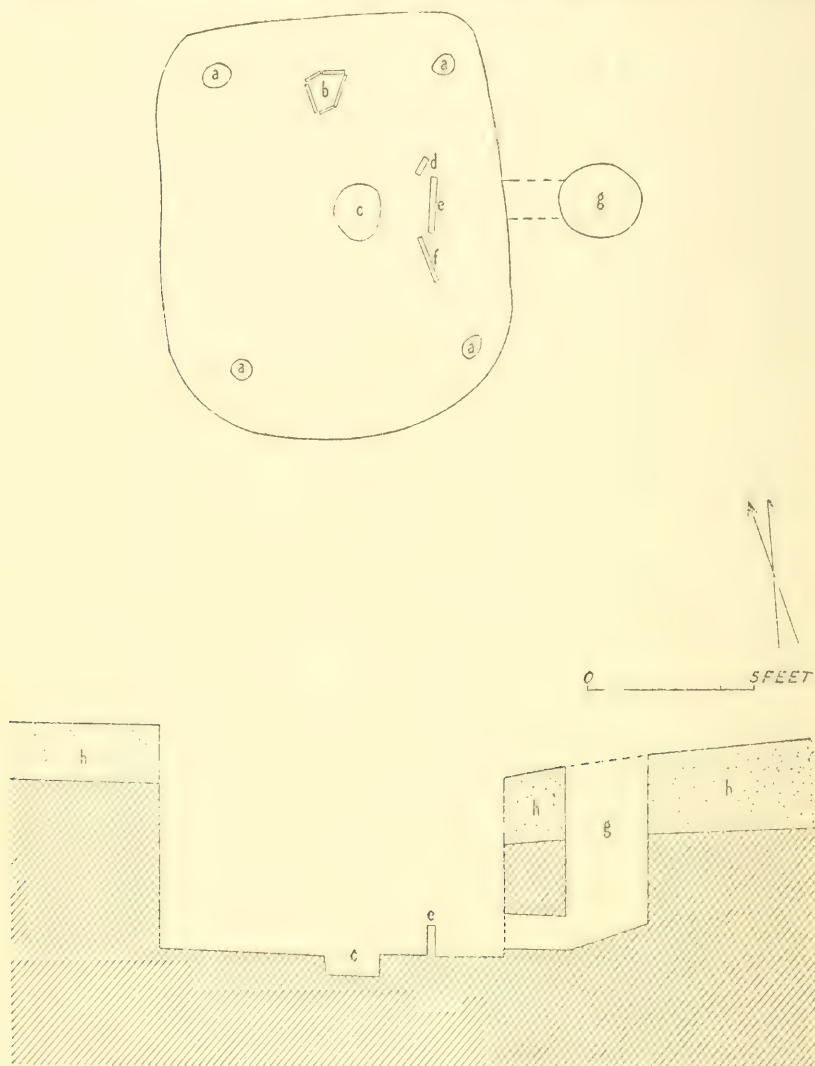
FIGURE 11.—Structure 4. *a*, holes for main support posts; *b*, storage box in floor; *c*, fire pit; *d*, standing stone; *e*, deflector; *f*, standing stone; *g*, ventilator shaft; *h*, sand accumulation above original surface.

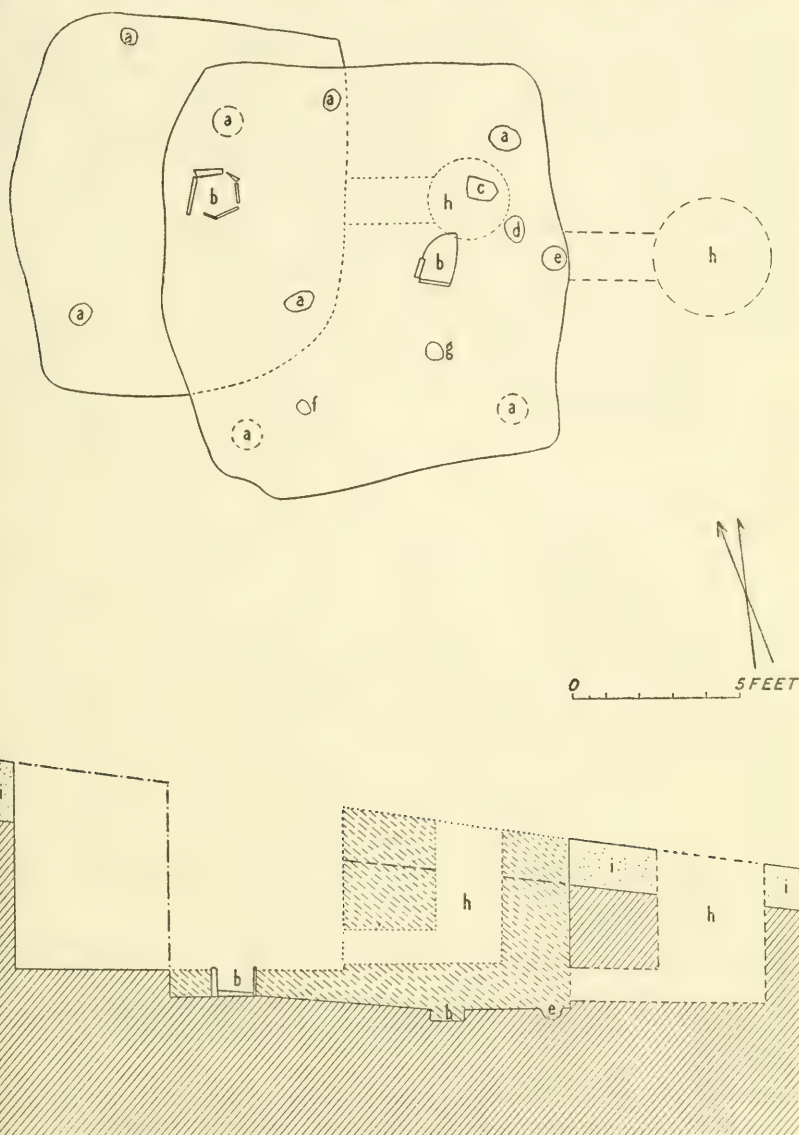
FIGURE 12.—Structures 5a and 5b. *a*, holes for main superstructure supports; *b*, fire pits; *c*, stone embedded in floor; *d*, basin in floor; *e*, hole in floor; *f* and *g*, storage holes; *h*, ventilator shaft; *i*, sand accumulation above old surface.

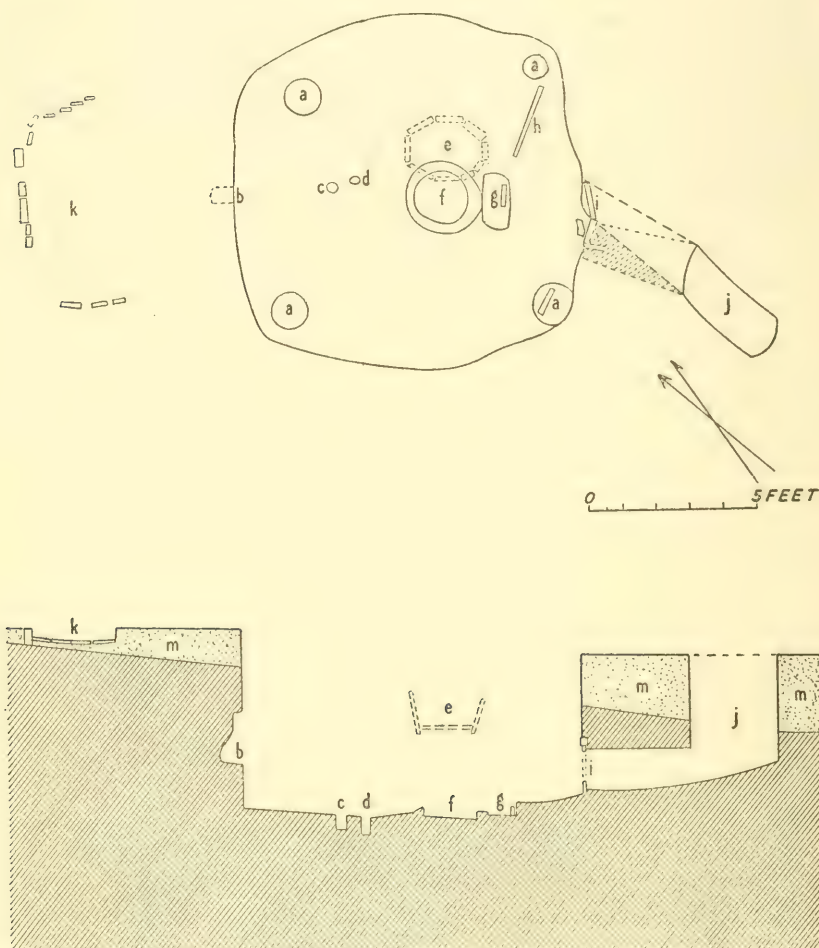
FIGURE 14.—Structure 6. *a*, holes for main roof supports; *b*, placement for roof brace; *c*, storage hole; *d*, sipapu; *e*, fire pit in fill; *f*, fire pit for 6; *g*, ladder pit; *h*, stone forming bin; *i*, ventilator stone; *j*, ventilator shaft; *k*, remains of granary; *m*, sand accumulation above old surface.

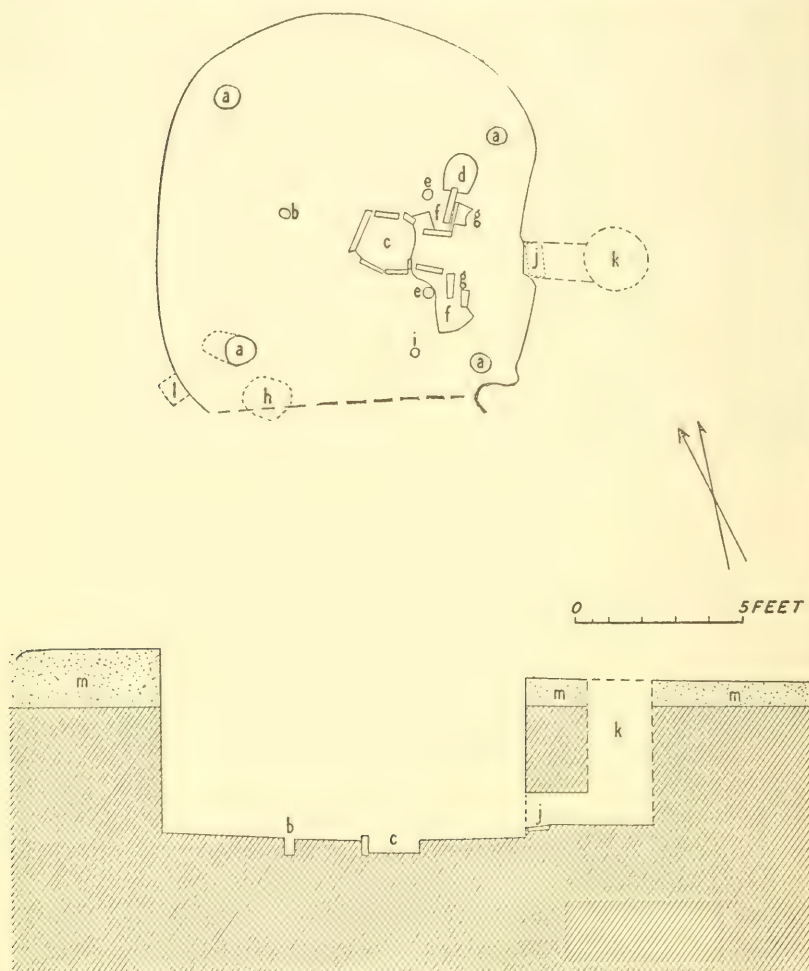
FIGURE 18.—Structure 9. *a*, holes for main support posts; *b*, sipapu; *c*, fire pit; *d*, fallen stone from compartment wall; *e*, holes for small poles; *f*, adobe plaster placement for compartment wall slabs; *g*, stones in compartment wall; *h*, location of support post for superstructure over 10; *i*, storage hole; *j*, ventilator opening and sill; *k*, ventilator shaft; *l*, placement for roof brace; *m*, sand accumulation above old surface.

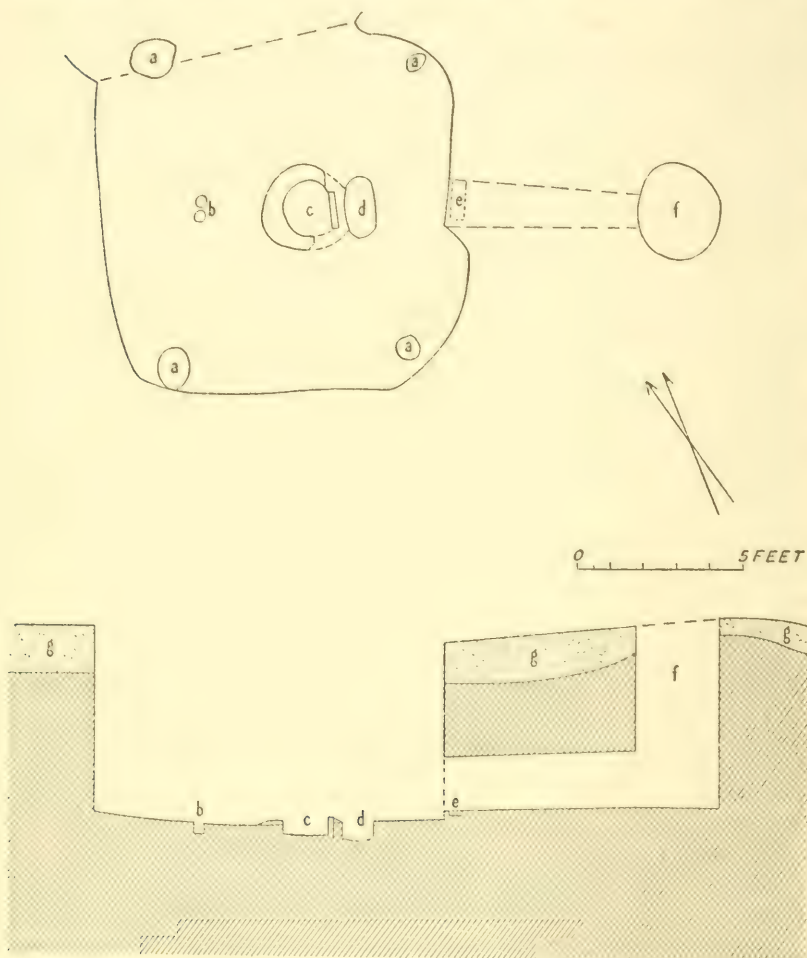
FIGURE 19.—Structure 10. *a*, holes for support posts; *b*, sipapu; *c*, fire pit; *d*, ladder box; *e*, ventilator opening; *f*, ventilator shaft; *g*, accumulation of sand above original surface.

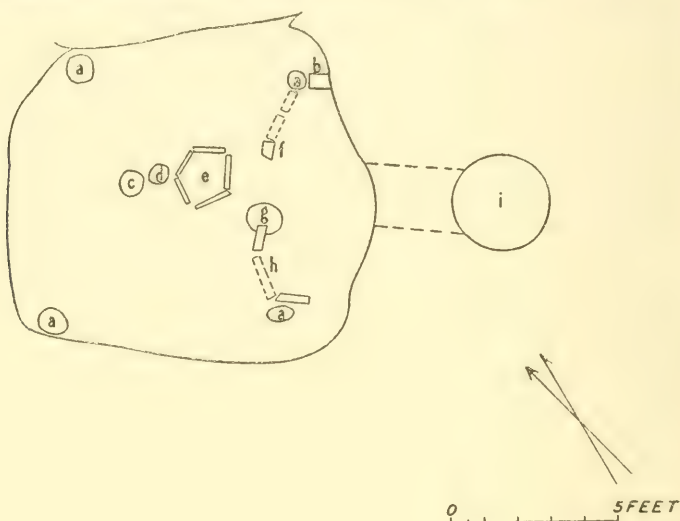
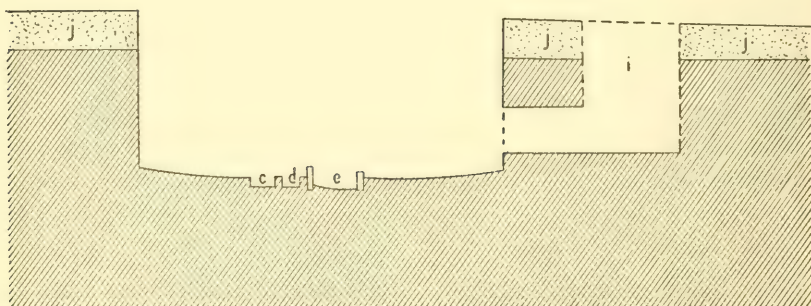
FIGURE 20.—Structure 11. *a*, holes for main support posts; *b*, stone in compartment wall; *c* and *d*, holes in floor in position of sipapu; *e*, fire pit; *f*, stone in compartment wall; *g*, storage basin; *h*, stone mold; *i*, ventilator shaft; *j*, accumulation of sand above original surface.

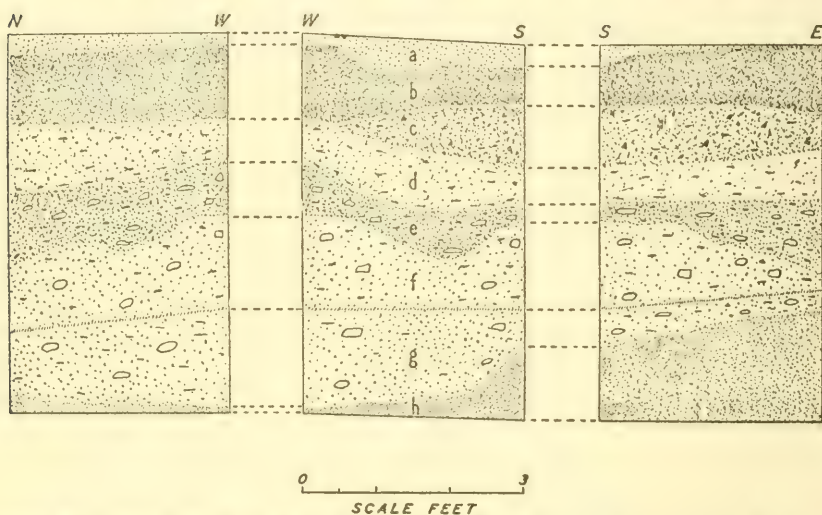
FIGURE 22.—Test pillar from fill in structure 10. N, W, S, and E, indicate north, west, south, and east corners.

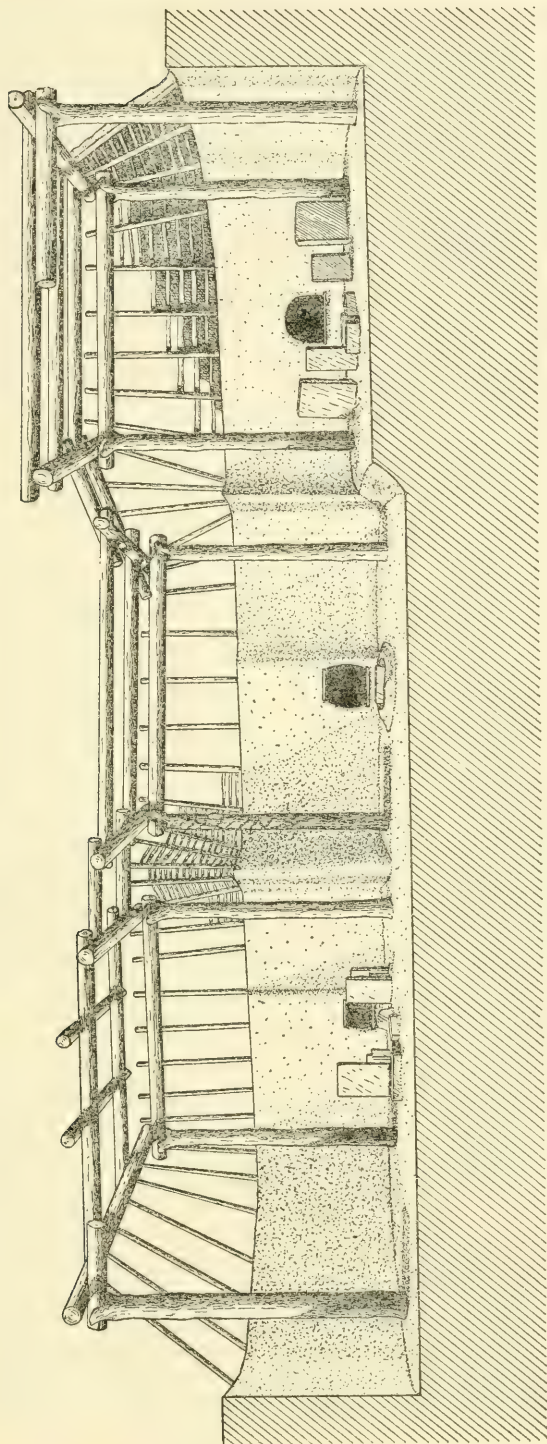
FIGURE 23.—Postulated reconstruction of timber arrangement in superstructure erected over pits 9, 10, and 11. Some of main support posts omitted at front of drawing to show construction more clearly.

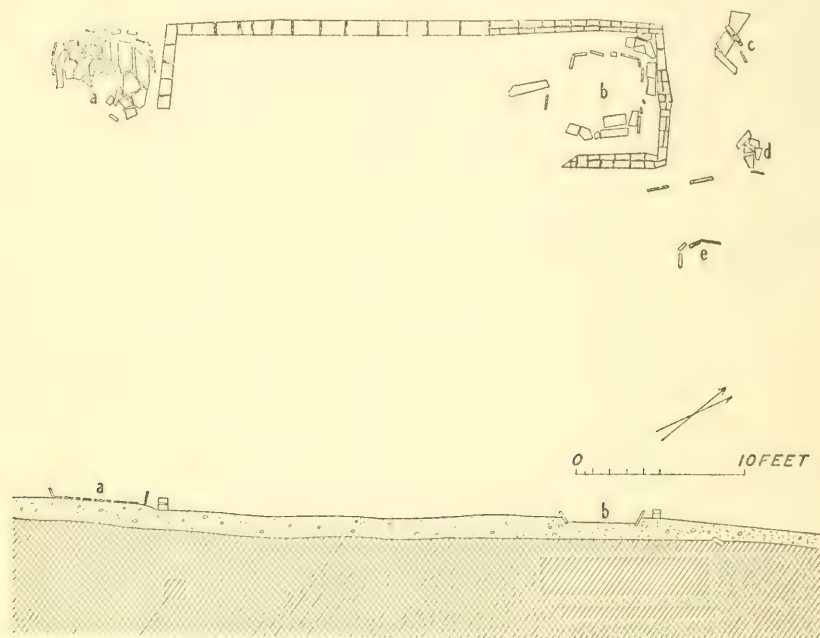
FIGURE 24.—Surface remains B in first group. Granary pits at *a*, *b*, *c*, and *d*; exterior fire pit at *e*.

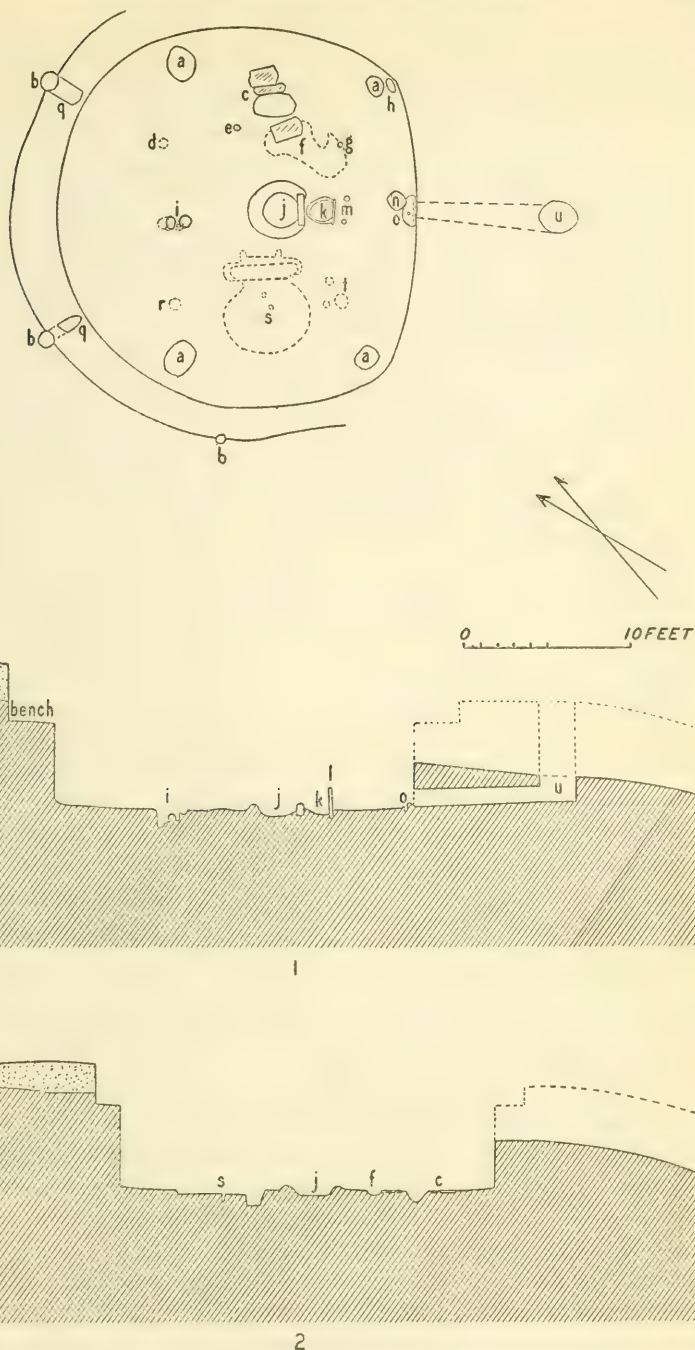
FIGURE 26.—Structure 12. *a*, holes for main support posts; *b*, secondary supports at back of bench; *c*, paving on floor; *d*, plastered-over hole in floor; *e*, storage hole; *f*, plastered-over basin; *g*, storage hole in floor; *h*, storage basin; *i*, sipapu holes; *j*, fire pit; *k*, ash pit; *l*, deflector; *m*, ends of ladder poles; *n*, cover stone for ventilator; *o*, shelf for cover stone and hole for small post to hold stone; *q*, plaster ridges on bench; *r*, plastered over hole; *s*, plastered over basin suggestive of subfloor kiva vault; *t*, plastered-over holes; *u*, ventilator shaft; *v*, sand accumulation.

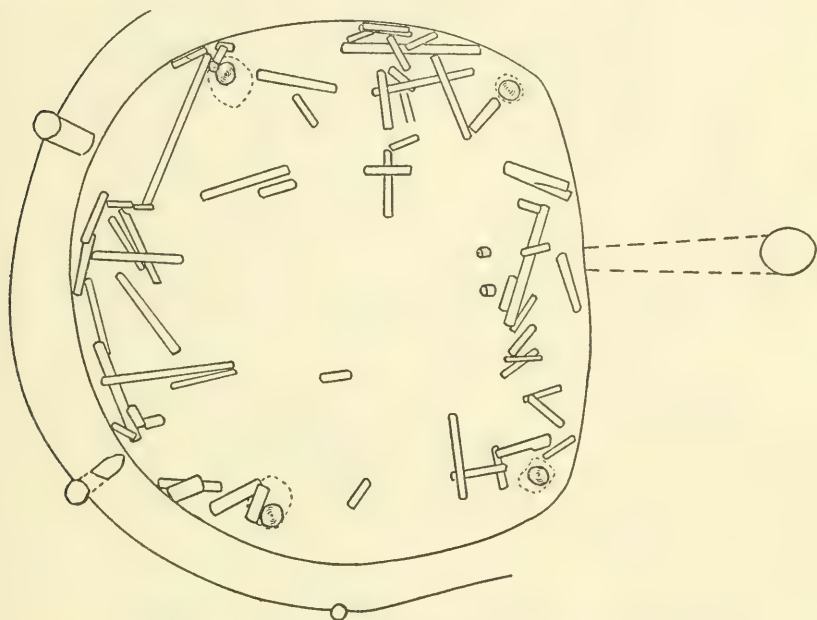
FIGURE 27.—Positions of burned timbers on floor of structure 12.

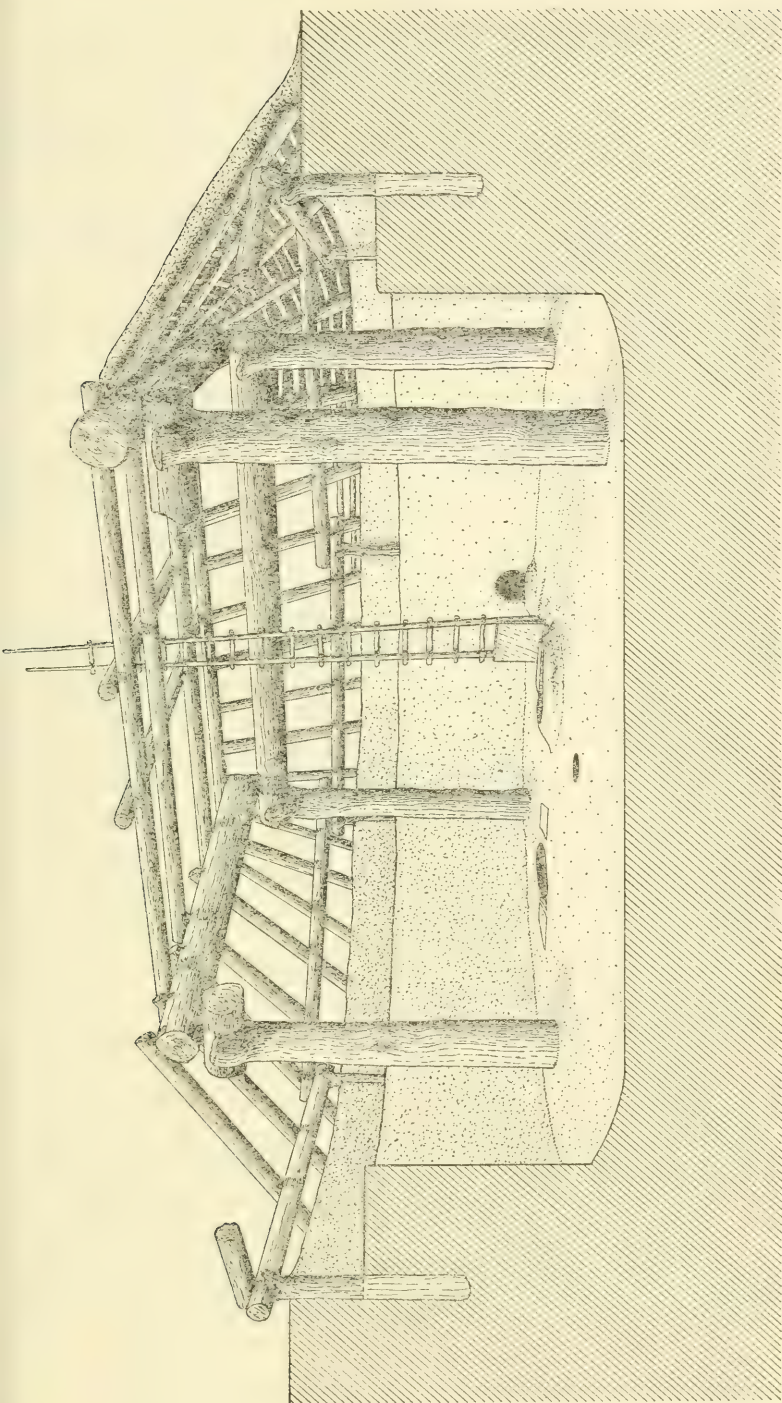
FIGURE 28.—Postulated reconstruction of superstructure erected over structure 12. Some of front timbers omitted from drawing so as not to complicate the diagram.

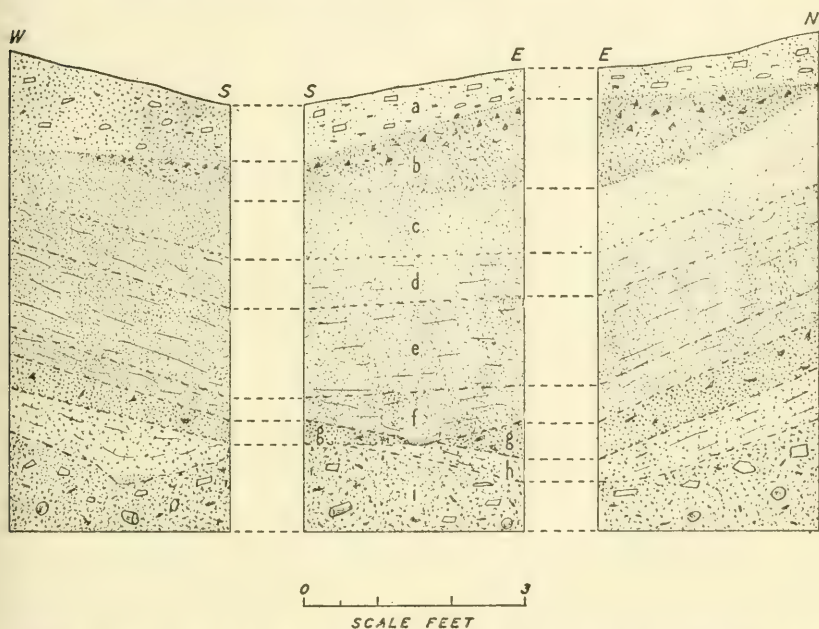
FIGURE 29.—Pillar left from fill in structure 12. E, W, N, and S indicate east, west, north, and south corners.

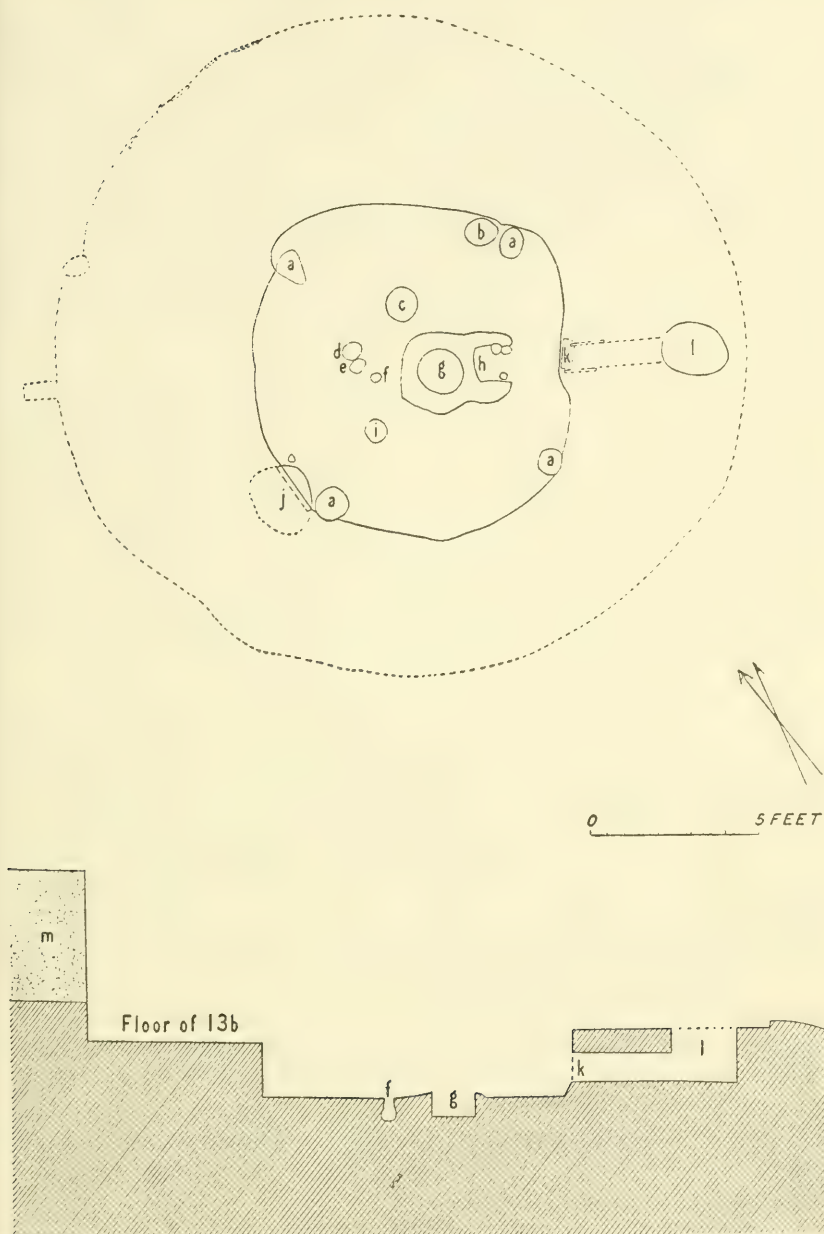
FIGURE 30.—Structure 13a. *a*, holes for superstructure support posts; *b*, *c*, *d*, and *e*, storage holes; *f*, sipapu; *g*, fire pit; *h*, ladder box; *i*, storage basin; *j*, storage pocket in wall; *k*, ventilator opening in chamber; *l*, ventilator shaft; *m*, accumulated sand. Dotted lines indicate position of 13b.

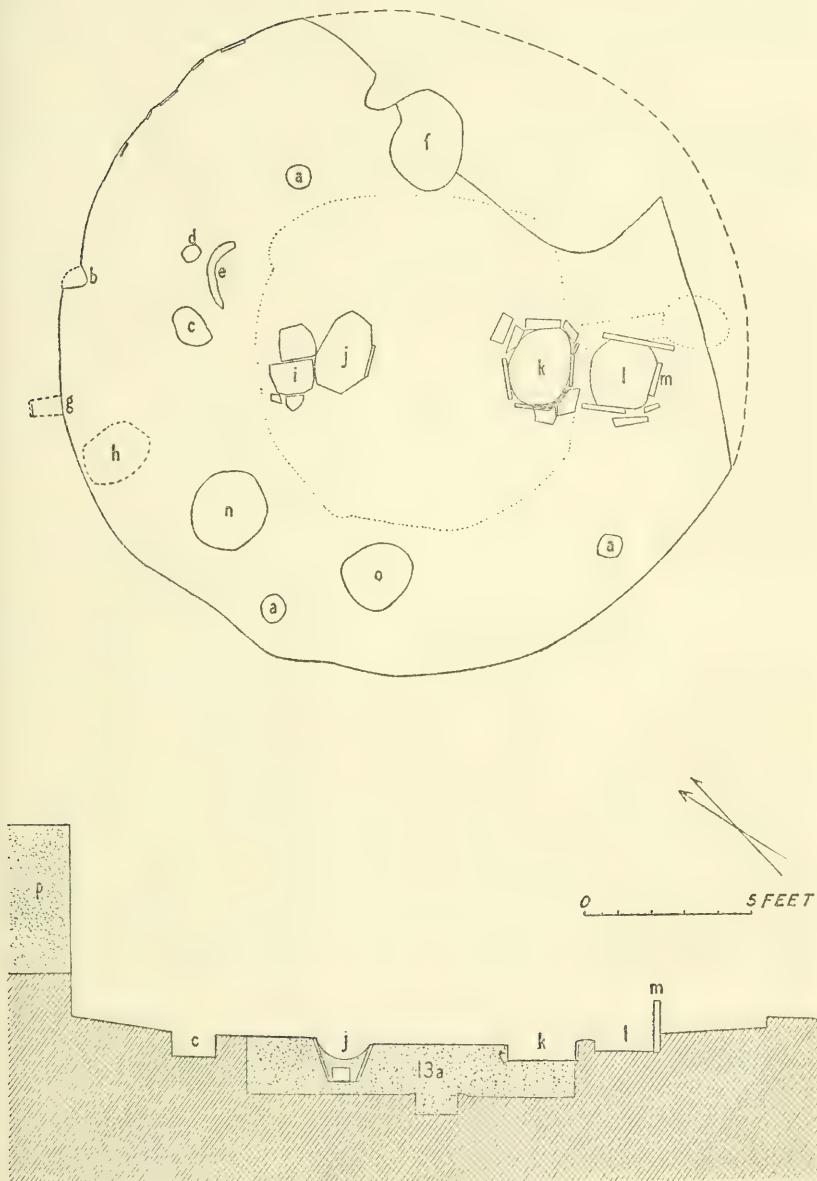
FIGURE 31.—Structure 13b. *a*, holes for main support posts; *b*, beam placement; *c* and *d*, storage holes; *e*, groove in floor; *f*, storage basin; *g*, wall pocket or Katchina niche; *h*, basin covered by floor plaster; *i*, stones embedded in floor; *j*, basin in floor; *k*, fire pit; *l*, ladder box; *m*, deflector stone; *n* and *o*, storage basins; *p*, drift sand. Dotted lines show position of 13a.

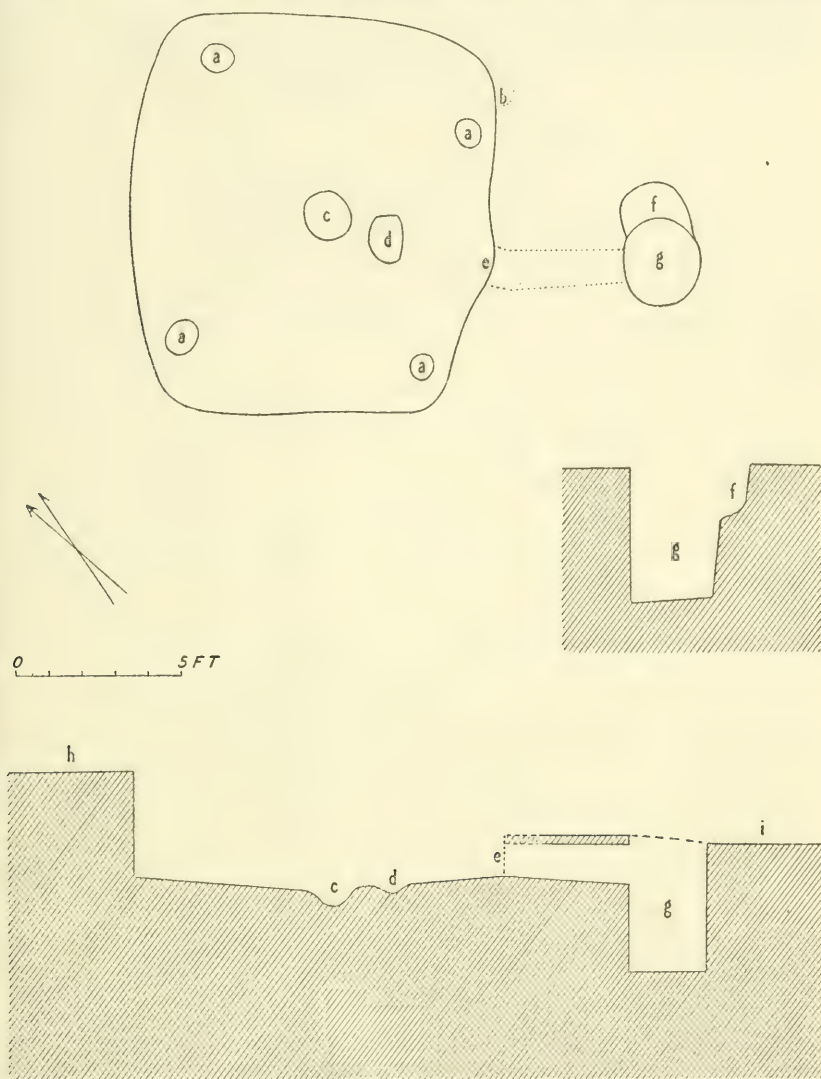
FIGURE 32.—Structure 14. *a*, holes for main support posts; *b*, wall pocket; *c*, fire pit; *d*, ladder box; *e*, ventilator opening; *f* and *g*, exterior opening to ventilator shaft; *h*, platform of dance court dais; *i*, floor of dance court.

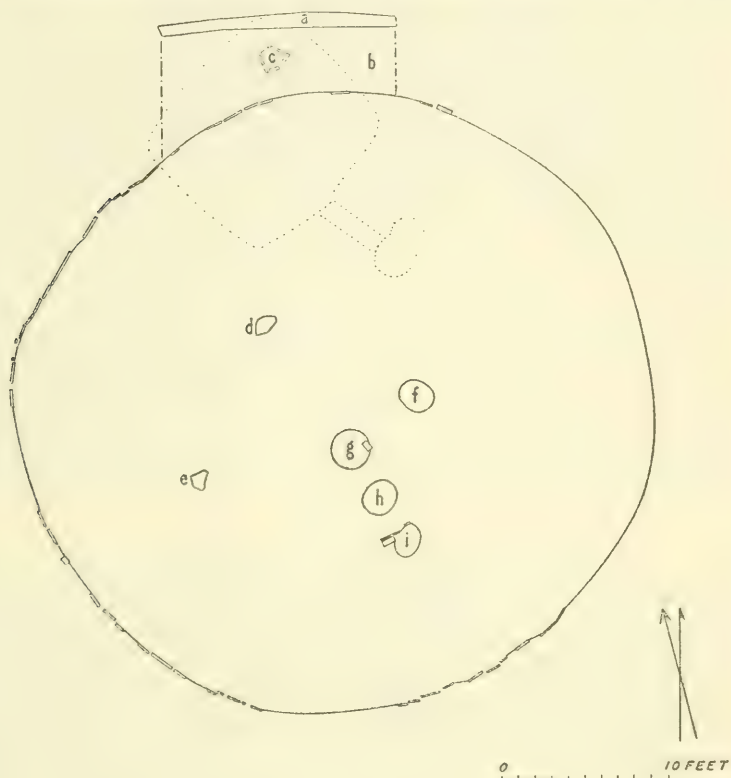
FIGURE 33.—Dance court. *a*, masonry wall; *b*, dais; *c*, fire pit; *d* and *c*, stones embedded in floor; *f*, basin in floor; *g*, fire pit; *h*, ash pit; *i*, basin in floor. Dotted lines show location of structure 14.

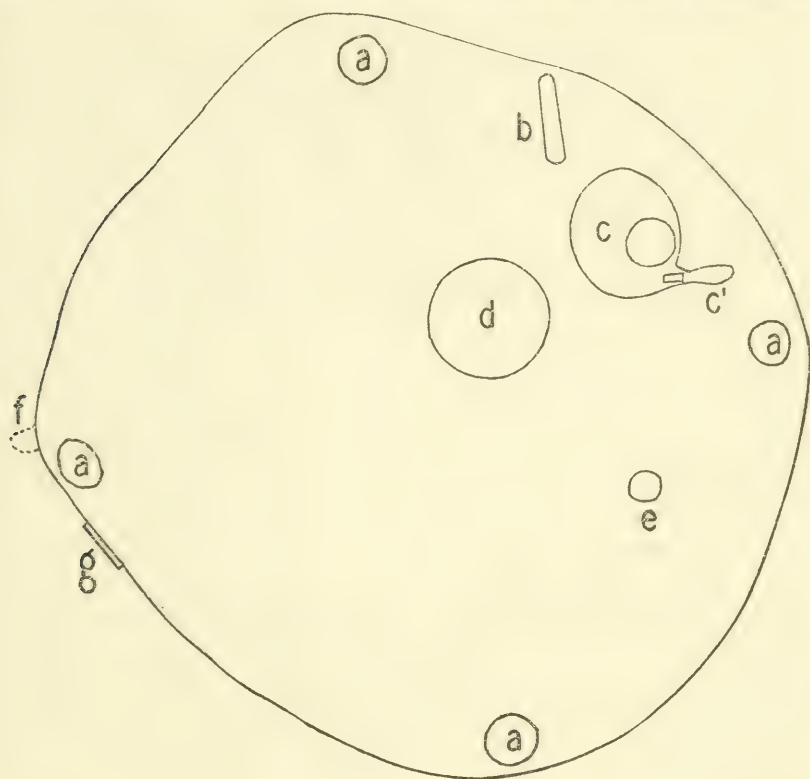
FIGURE 34.—Brush shelter. *a*, holes for support posts; *b*, stone in floor; *c*, storage pit in floor; *d*, fire pit; *e*, storage hole in floor; *f*, placement for roof brace; *g*, slab in wall.
